## **Ehen Compensatory Measures**

United Utilities

### **Crummock Water Abstraction Infrastructure Removal - Full Technical Report**

04 | Final

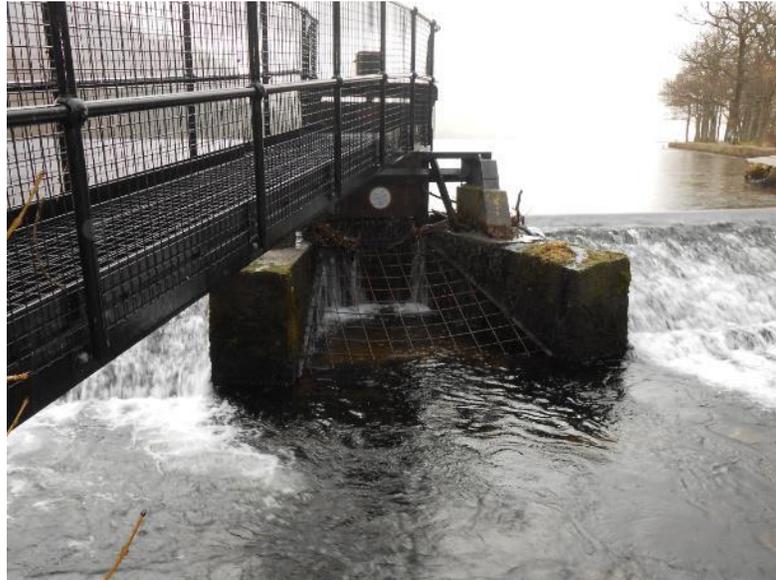
The existing drawdown facility for the lake consists of two manually controlled sluice gates, located either side of the fish pass feeding into two identical drawdown channels. Both channels are 2.5m long and taper from 1m wide at the upstream end to 2m wide at the downstream end. The sluice gates (Figure 4-2) can be raised manually to give an opening height of approximately 1m (no telemetry was evident on site) and access to each sluice gate is via metal footbridges with locked gates. Condition of the bridges suggests that these have been recently replaced.

Figure 4-2: Sluice Gate

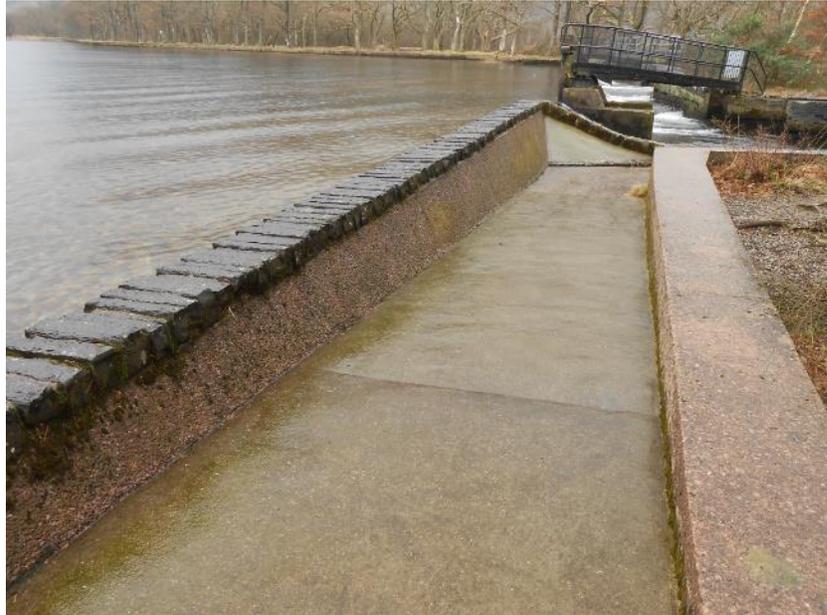
**Figure 4-3: Overflow channel**

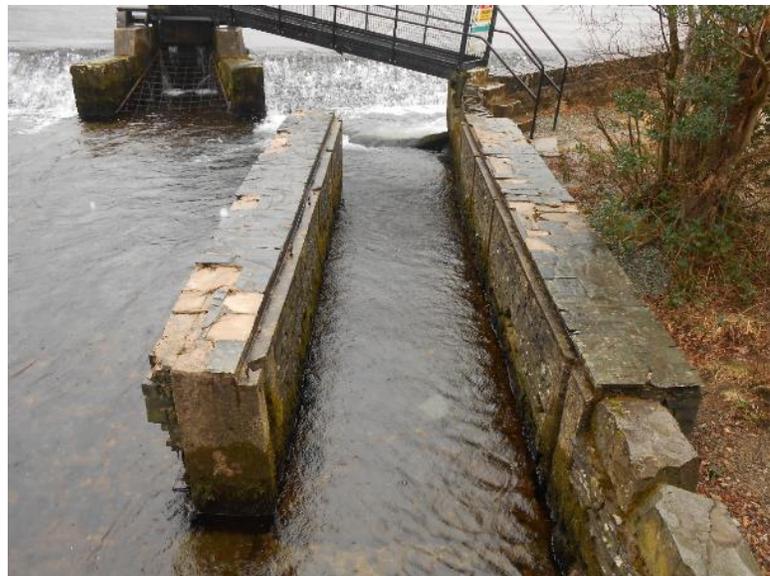
**Figure 4-4: Masonry Walls**

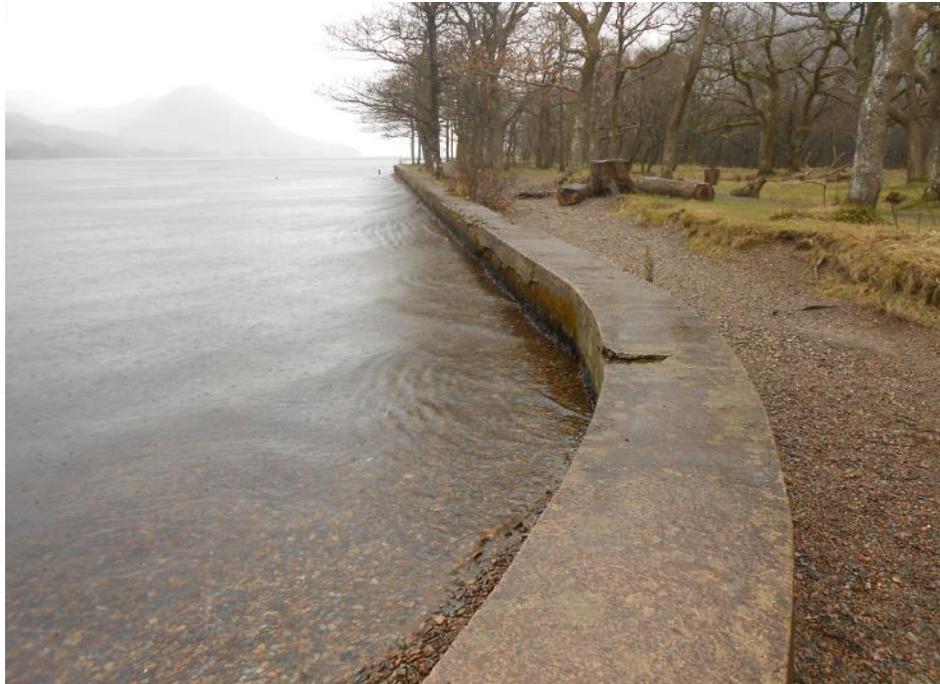
A 300m long concrete wave wall running along the west shore of the lake between the weir and the pump house is in good condition, with minor signs of weathering and spalling concrete evident (Figure 4-6). The wall is approximately 0.45m wide, 0.5m high above the natural ground level and ties into the retaining wall on the left-hand side of the weir. The level of the wall at this point is approximately 0.55m above the weir crest. The depth of the wall below the ground level is unknown.

Figure 4-6: Length of adjacent wall

Historical drawings suggest that this wave wall could have been constructed in the late 1900s following a period of bank erosion.

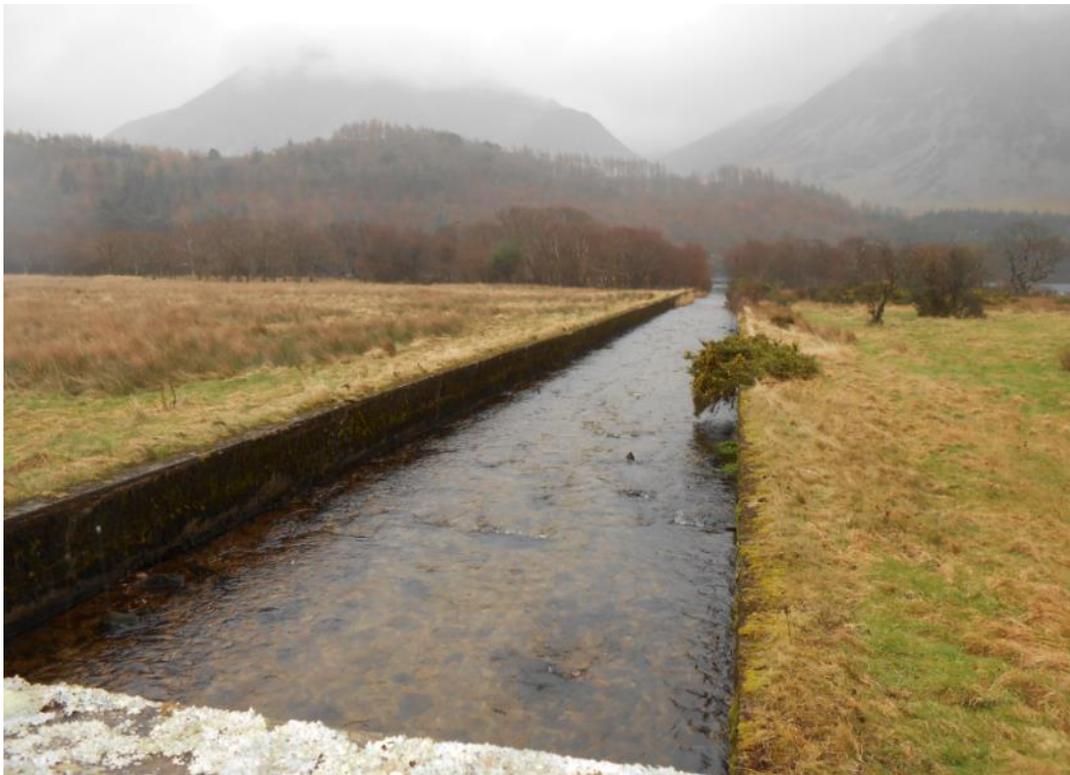
Figure 4-7). Along this length the channel has been straightened, with a concrete lining along the full length of the left bank and a concrete and masonry lining along the right bank as illustrated in Figure 4-8. The upstream channel appears to be in a good condition, whilst the downstream end of the channel is overgrown and poorly maintained.

Figure 4-7: Park Beck facing downstream to Crummock Water

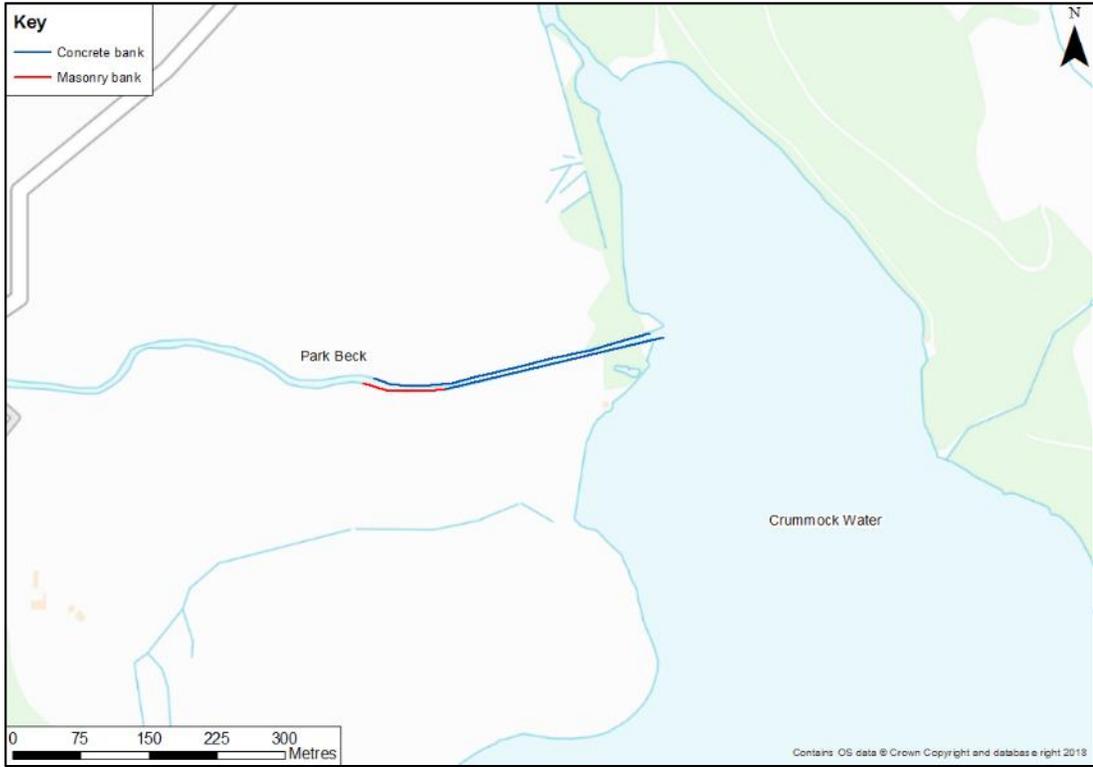
Figure 4-8: Park Beck bank engineering (bank lining marked in blue (concrete) and red (masonry))

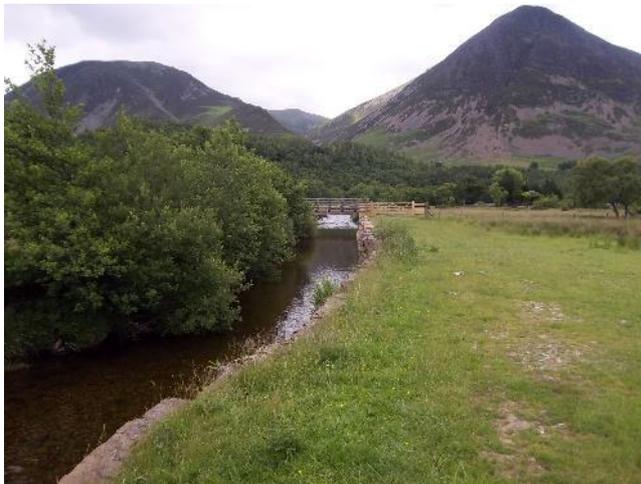
c) Channel banks reinforced for a significant length of the lower reaches of Park Beck with stone and concrete material.

Immediately upstream from the confluence with Crummock Water, the channel has been extensively modified by channel straightening and bed and bank reinforcement. It is possible that the channel was originally modified to minimise channel movement and to control the inflow point into the lake to protect the pumping station from erosion. The modifications are also likely to cause a reduction of lateral connectivity with the adjacent floodplain, serving to reduce flooding and increase the water volume delivered to the lake. Sediments within the modified channel are typically larger clasts (i.e. cobbles, with isolated deposition of fine sediment). This suggests that sediment is efficiently transported along this length of the river at most flows. Borehole surveys undertaken in 2018 (Geotechnics, 2018), revealed that the topsoil (< 0.2m) in the mid to lower lengths of the Park Beck contains a layer of silts and sands with some fine to coarse gravels. The layer beneath generally contains fine to coarse sands and gravels changing to a predominantly clay layer with increased depth. This is followed by cobbles, boulders or clays at around 2.6 m.

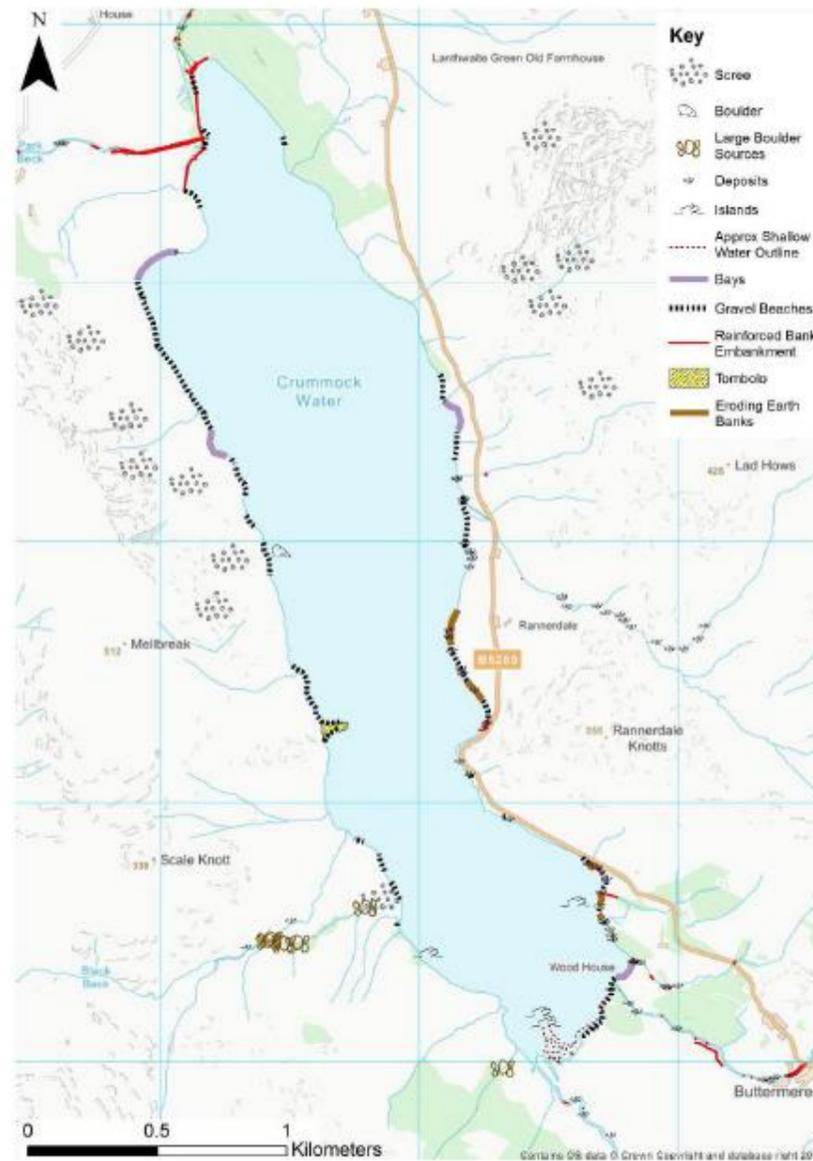
Figure 4-13: Flow and sediment conceptual models for Crummock Water focused study area
