UUWR_32

PR24 Draft Determination: UUW Representation

Area of representation: Cost and PCD - Water WINEP

This document outlines the UUW response to the draft determination for UUW_60
“Water WINEP”

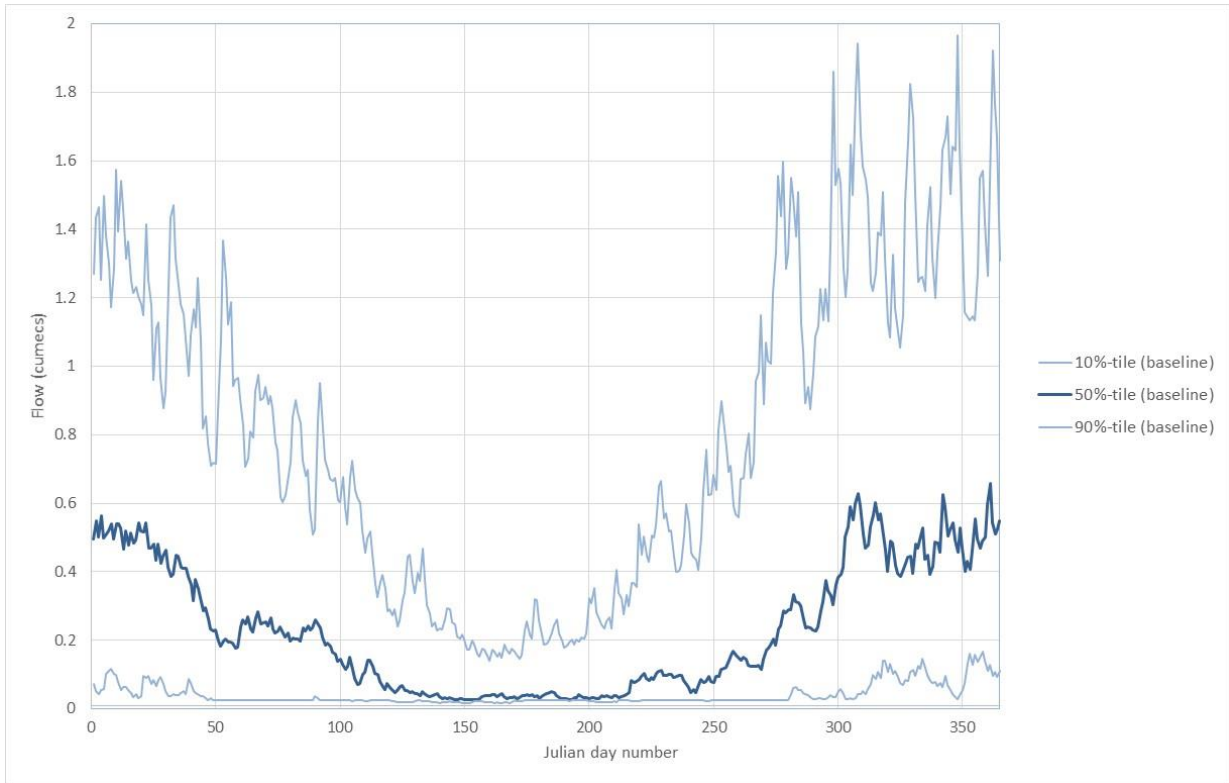
Figure 4-6: River Ellen flow (downstream of Chapelhouse system) - predicted baseline flow seasonality

Hydrological models were constructed of the system to support the understanding of the baseline flow and level conditions. Full details on the approach and baseline are outlined in Appendix B, including graphical representations of the normal and low flow regimes. Predicted flow seasonality of both the River Ellen and the Over Water Beck are shown in Figure 4-6 and Figure 4-7. Predicted low flow conditions are experienced throughout the Summer months as a consequence of abstraction and impounding infrastructure, with no flow conditions common on the Over Water Beck during this period.

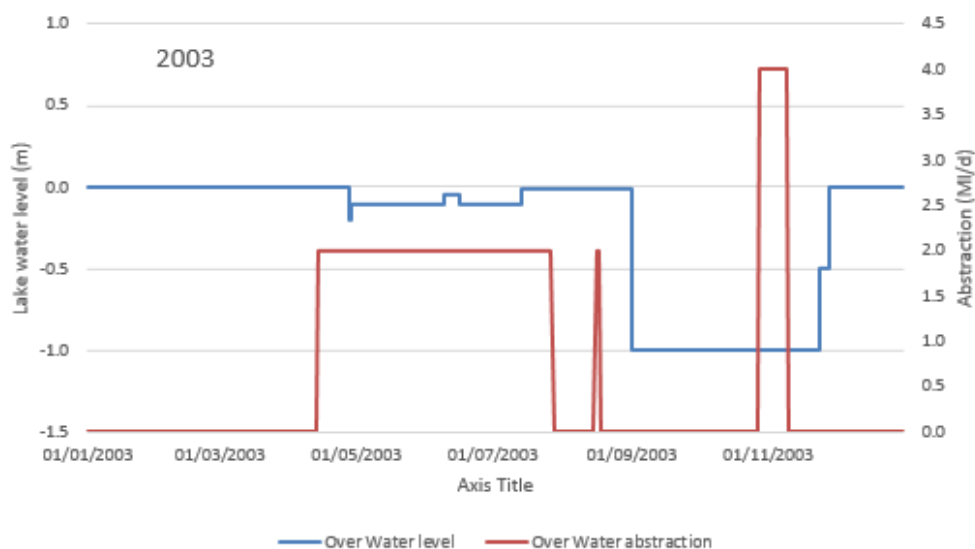
Figure B-5: Example of blocky nature of the observed record in 2003 for Over Water lake level and abstraction rate. Lake water level is relative to weir crest level.

In most of the record the observations do not change from day to day. Rather they appear as blocks of multiple days assigned the same value. At the end of one block a new block value appears which can again remain constant for a relatively long period. This can result in unrealistic step changes in lake level which cannot be explained by short-period high rates of abstraction (based on cross reference to the provided abstraction records). Figure B-5 shows an example of this behaviour during 2003. This strongly suggests that observed levels have not been made at a daily frequency, but that in much of the record occasional observations have been recorded and extrapolated until another observation takes its place. This in many cases will mask the actual variability of the water level which will need to be recorded at close to a daily frequency if abstractions are to be accurately represented.

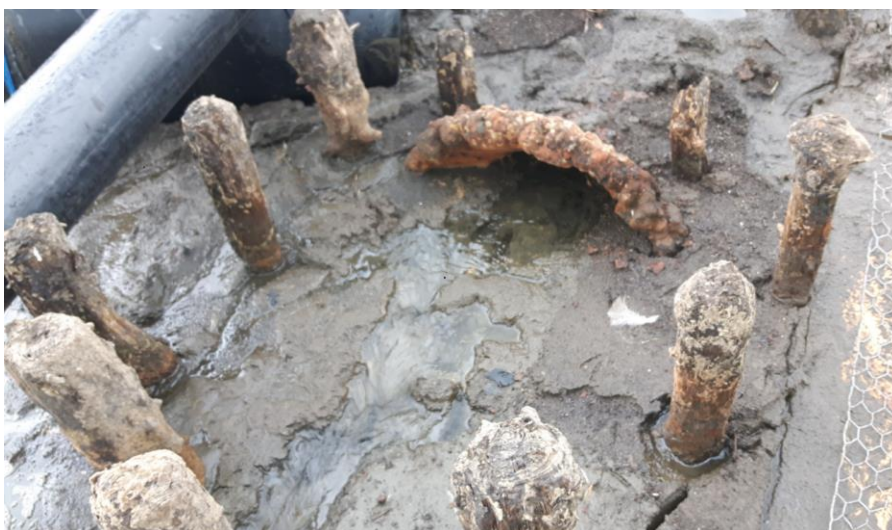
Figure B-7: The partially blocked state of the Over Water intake pipe that transfers water to Chapelhouse, observed during the 2018 drought

Another potential concern is the state of the transfer pipe from Over Water to Chapelhouse. Figure B-7: Figure B-7 shows the largely blocked state of the pipe observed during the 2018 drought. It is not known if such a blockage would invalidate the estimate of the recorded transfers, or if the abstraction pipe was in this state during the 2000 – 2014 period.

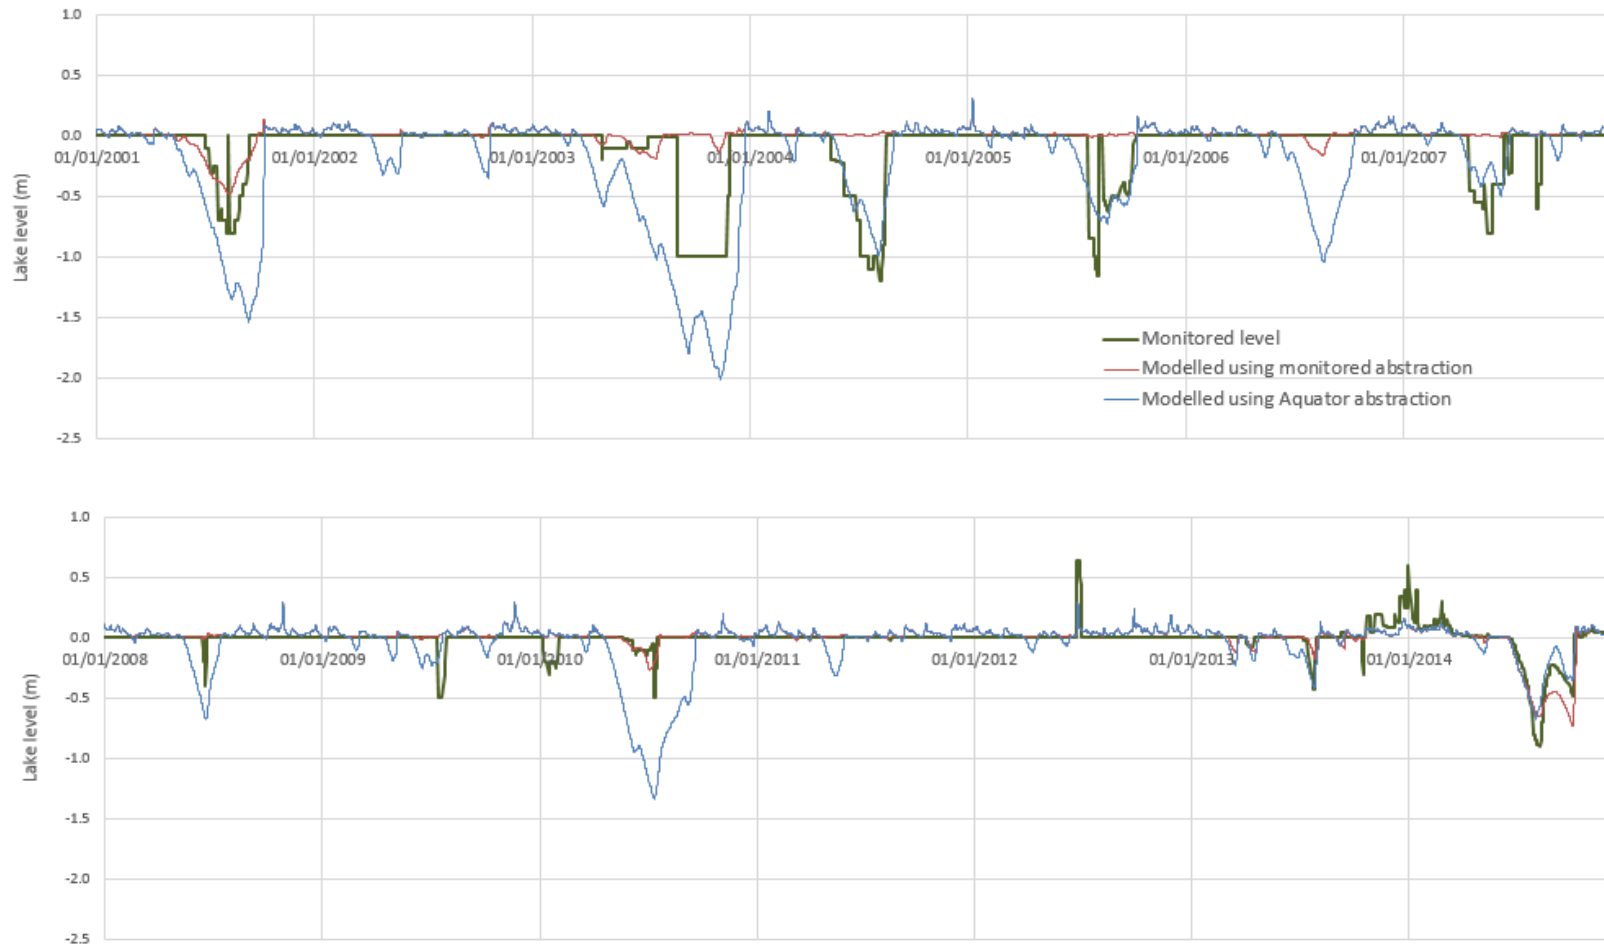
Figure B-8: Comparison of observed lake level to modelled lake level based on recorded "daily" abstraction (top graph) and abstraction rate used in the United Utilities water resource Aquator model (bottom graph). NB: Lake level is relative to weir crest

The representation of the observed data that is thought to be more reliable gives some confidence in the ability of the model to represent reality. However, the validation evidence given is limited and it is suggested that the findings of this study be interpreted as only indicative.

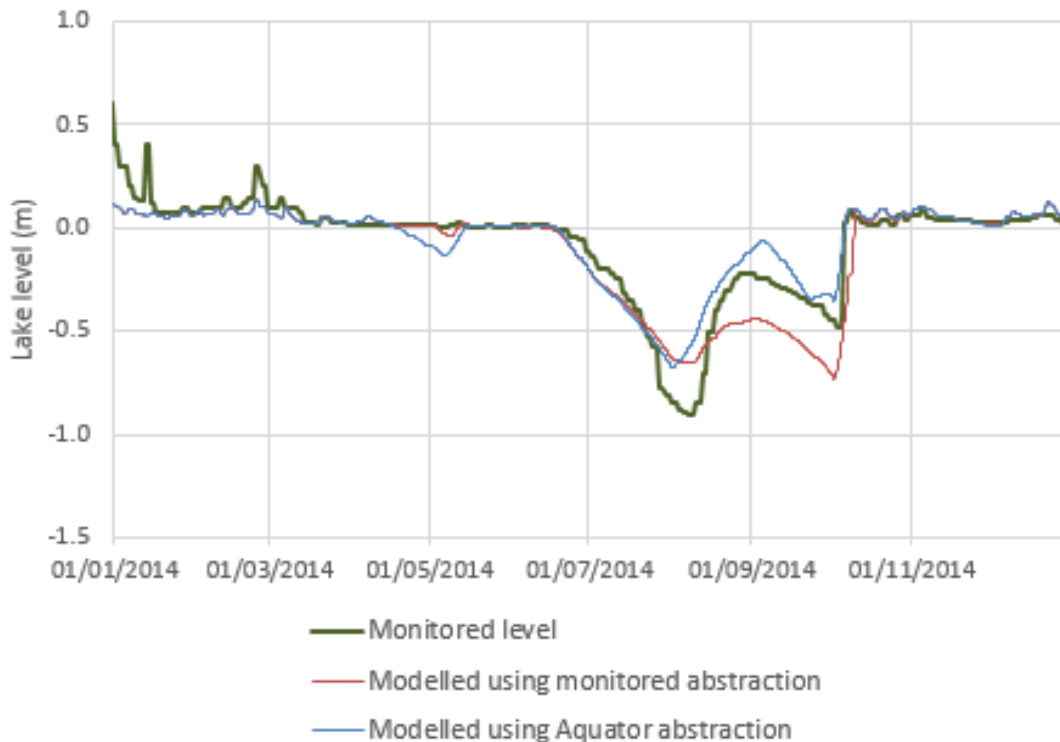
Figure B-9: Comparison of simulated Over Water level against observed data for 2014.

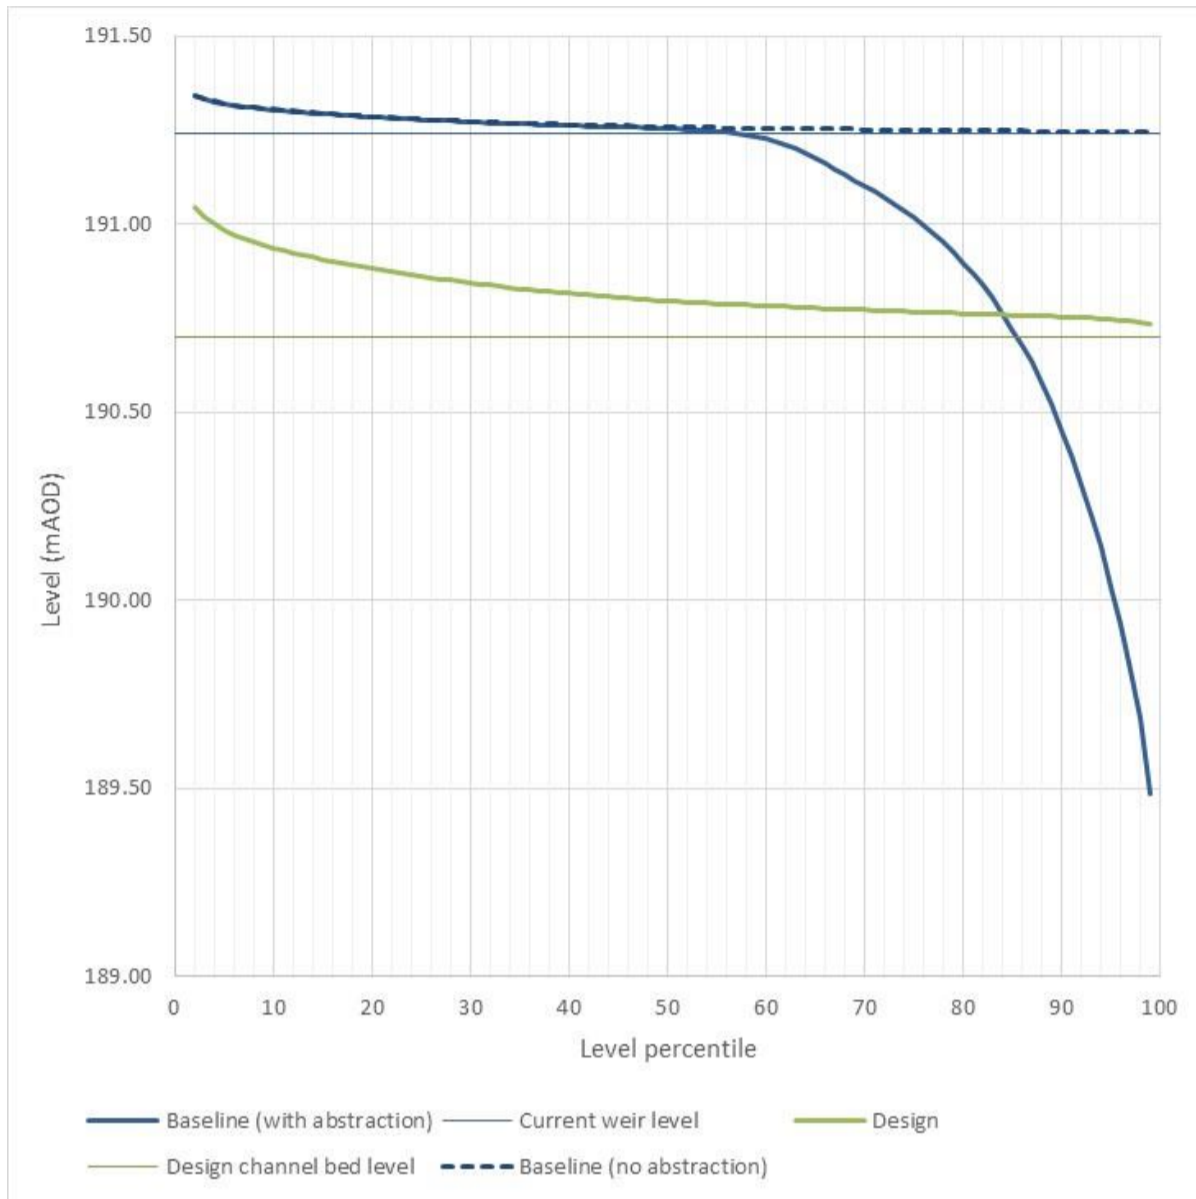
Figure B-10: Over Water level-duration curves for baseline and design scenarios.

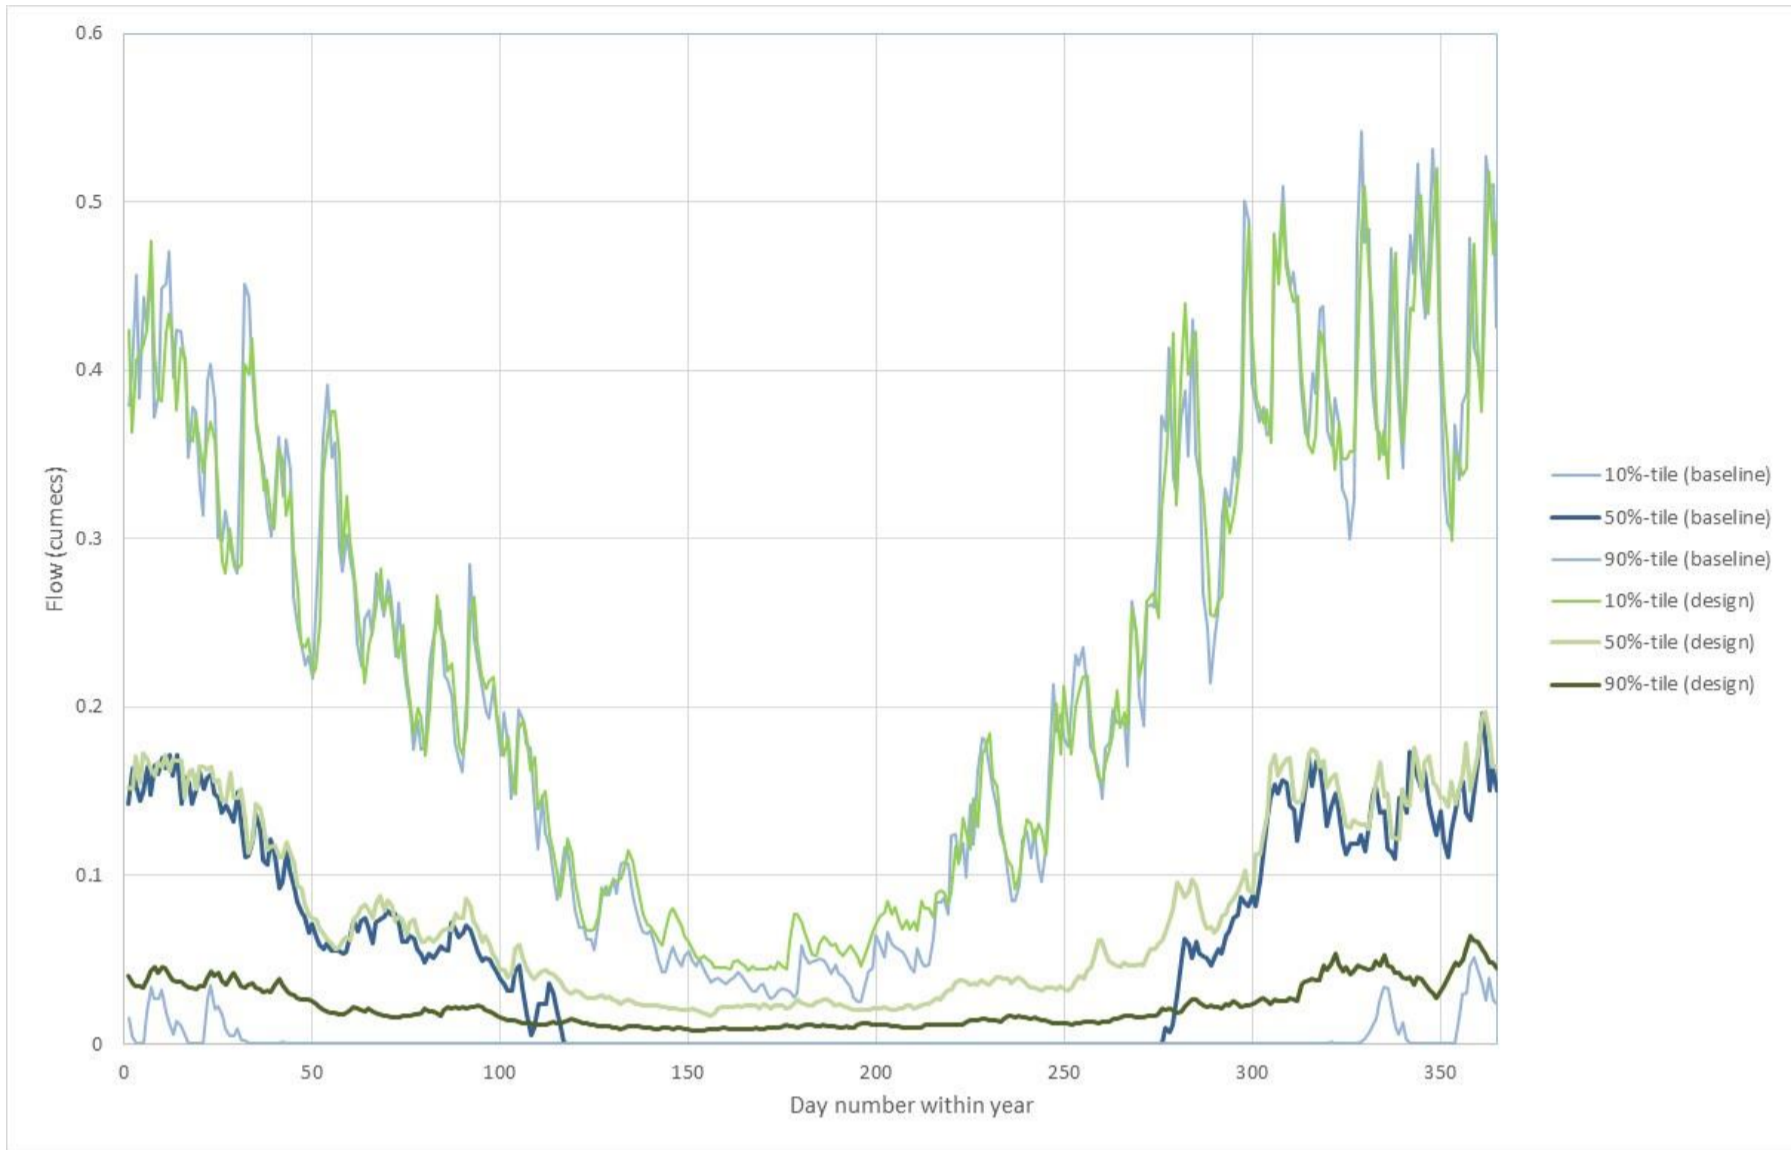
Figure B-13: Over Water Beck predicted flow seasonality for baseline and design scenarios

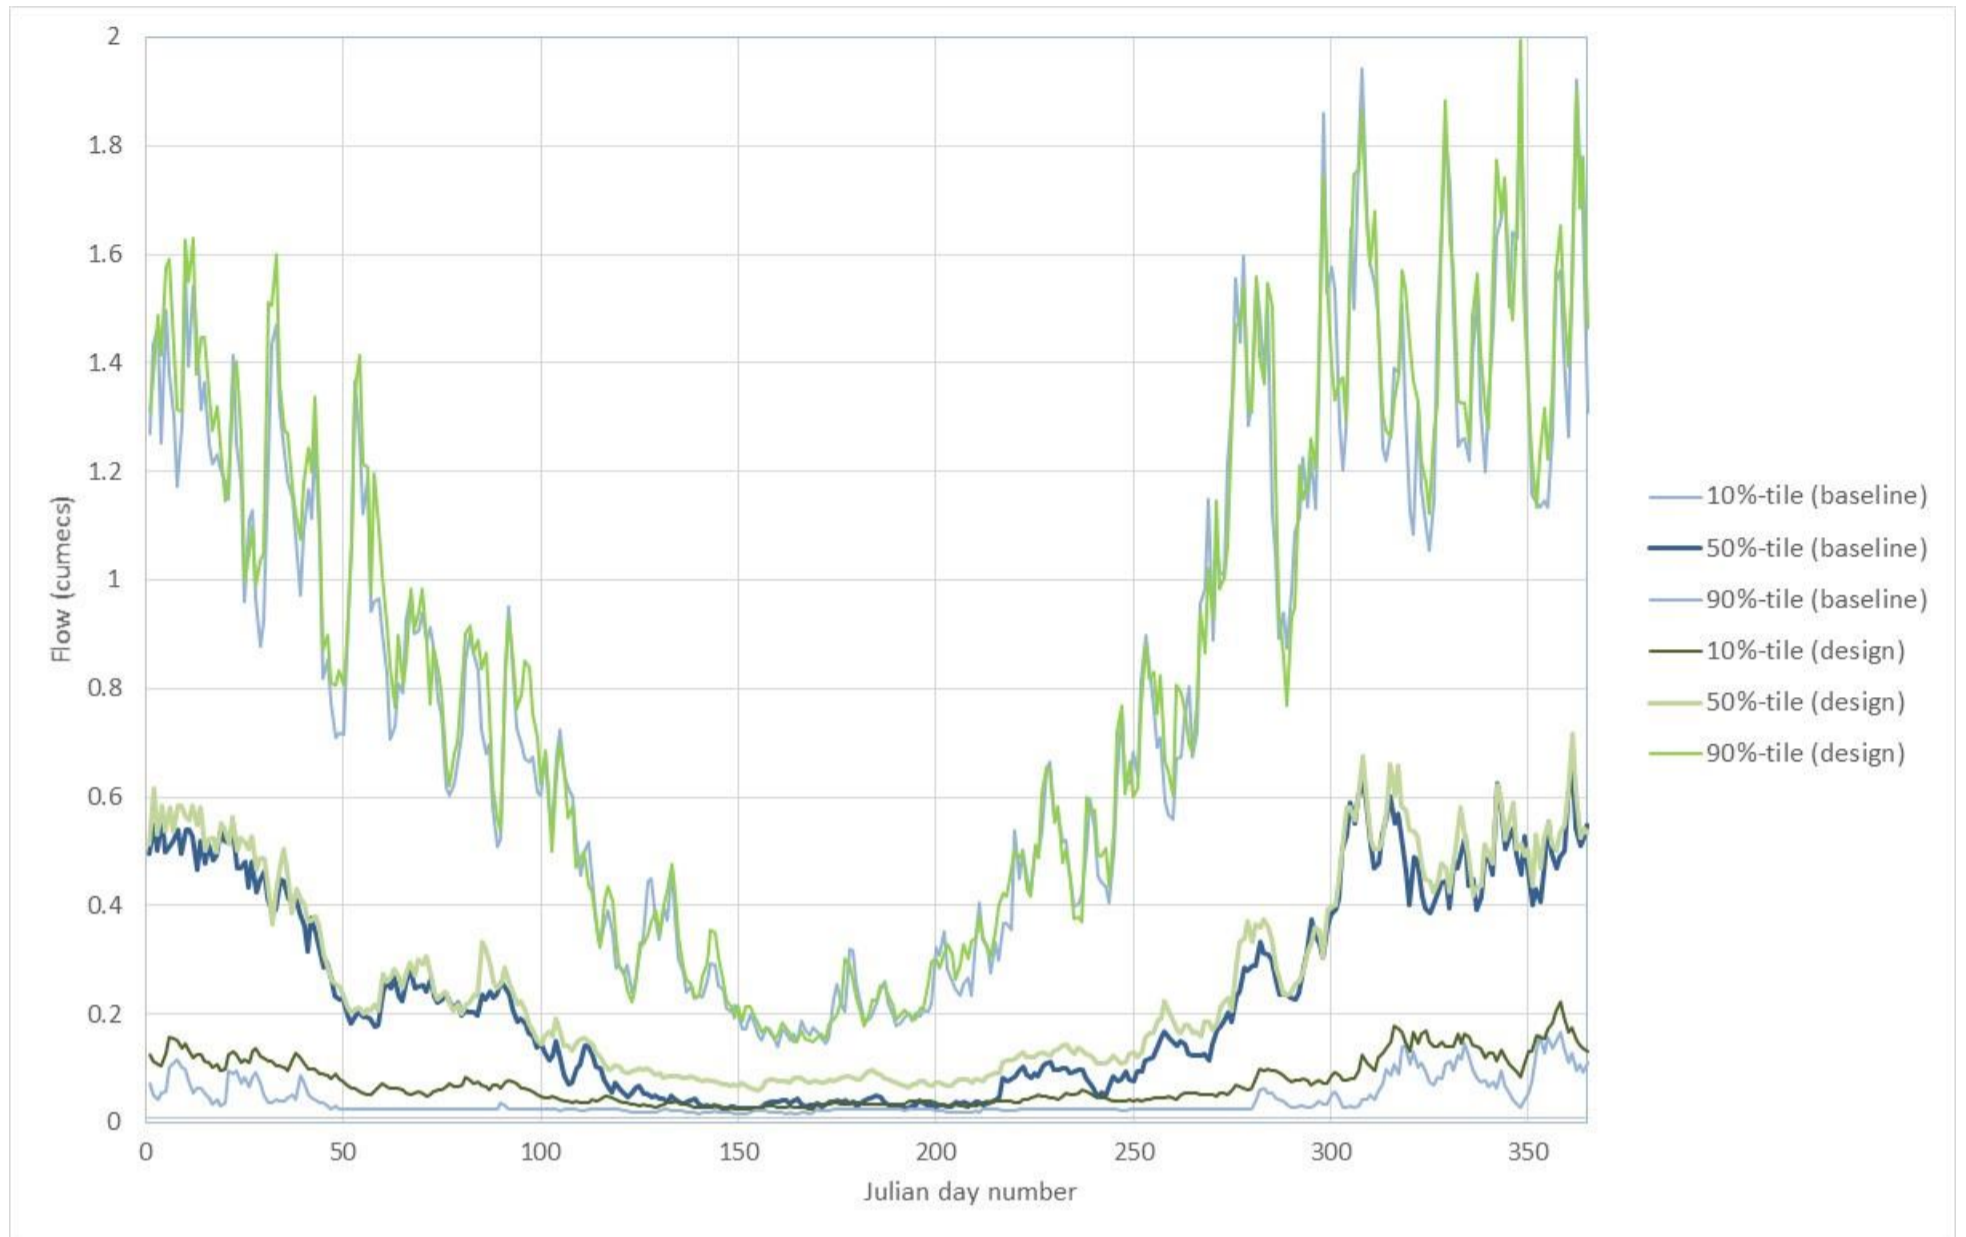
Figure B-15: River Ellen (immediately downstream of Chapelhouse) predicted flow seasonality for baseline and design scenarios

Figure B-14 and Figure B-15 show the equivalent representation of flow in the River Ellen immediately downstream of Chapelhouse Reservoir. This suggest that a distinct betterment in the flow regime in the Ellen will occur, particularly for low to medium flows in the range of Q90 to Q50 under the proposed design. This improved flow regime is predicted to be particularly noticeable during the summer and early autumn.

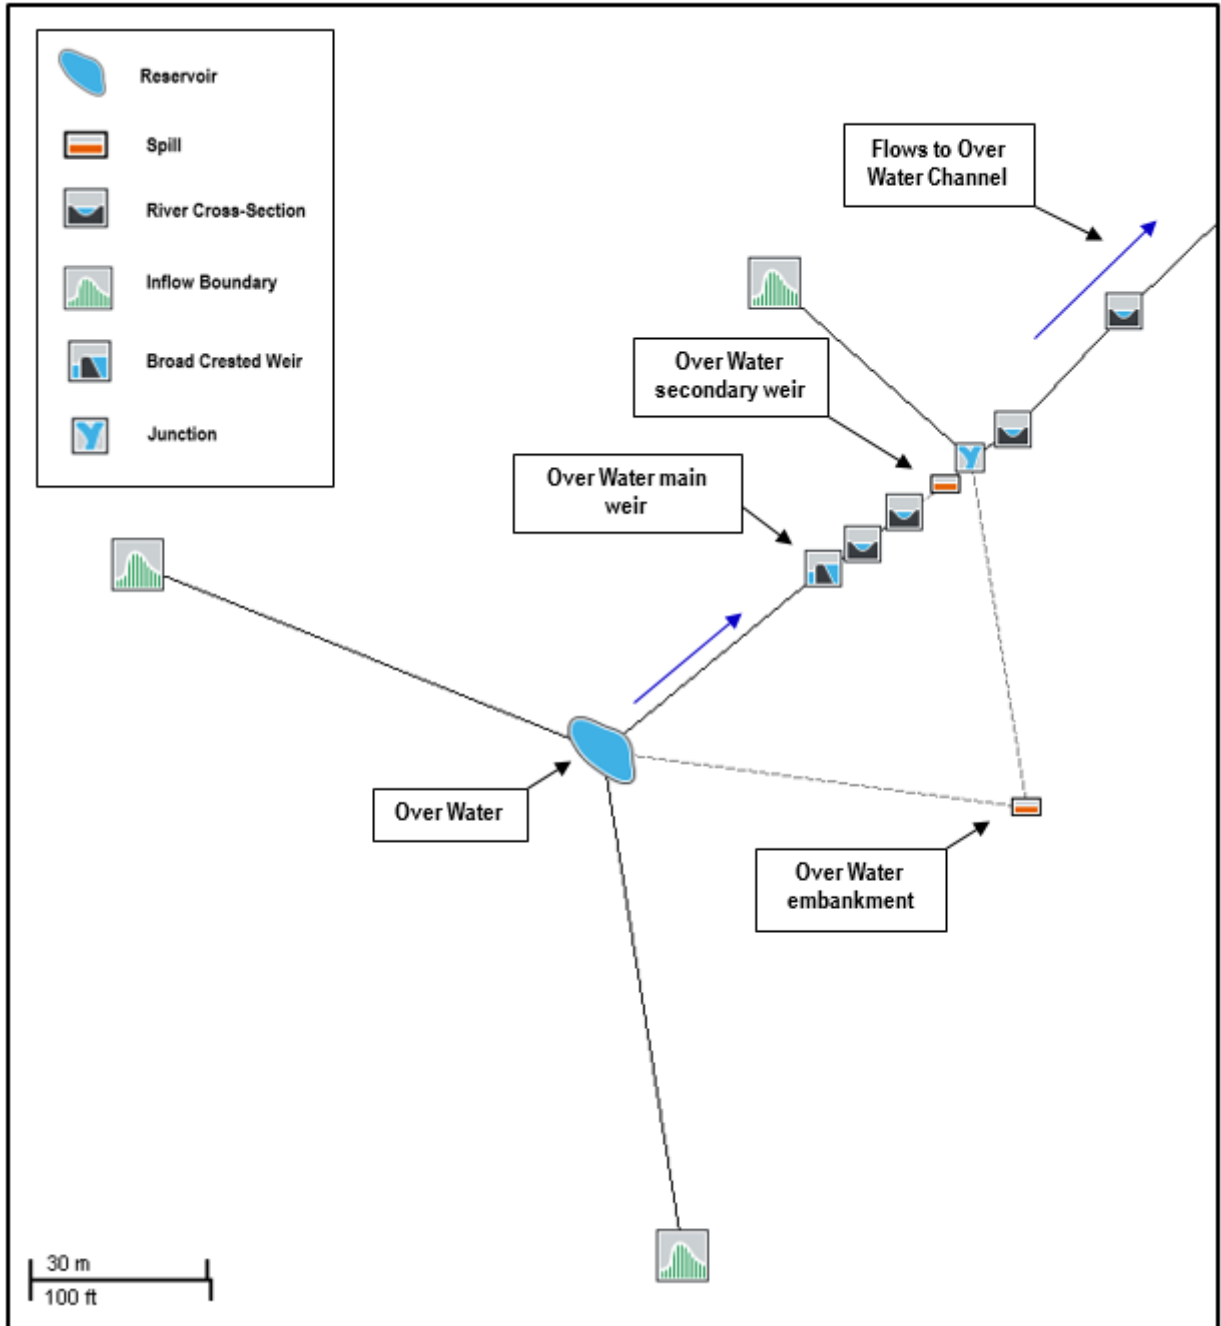
Figure C-2: Schematisation of the Overflow from Over Water

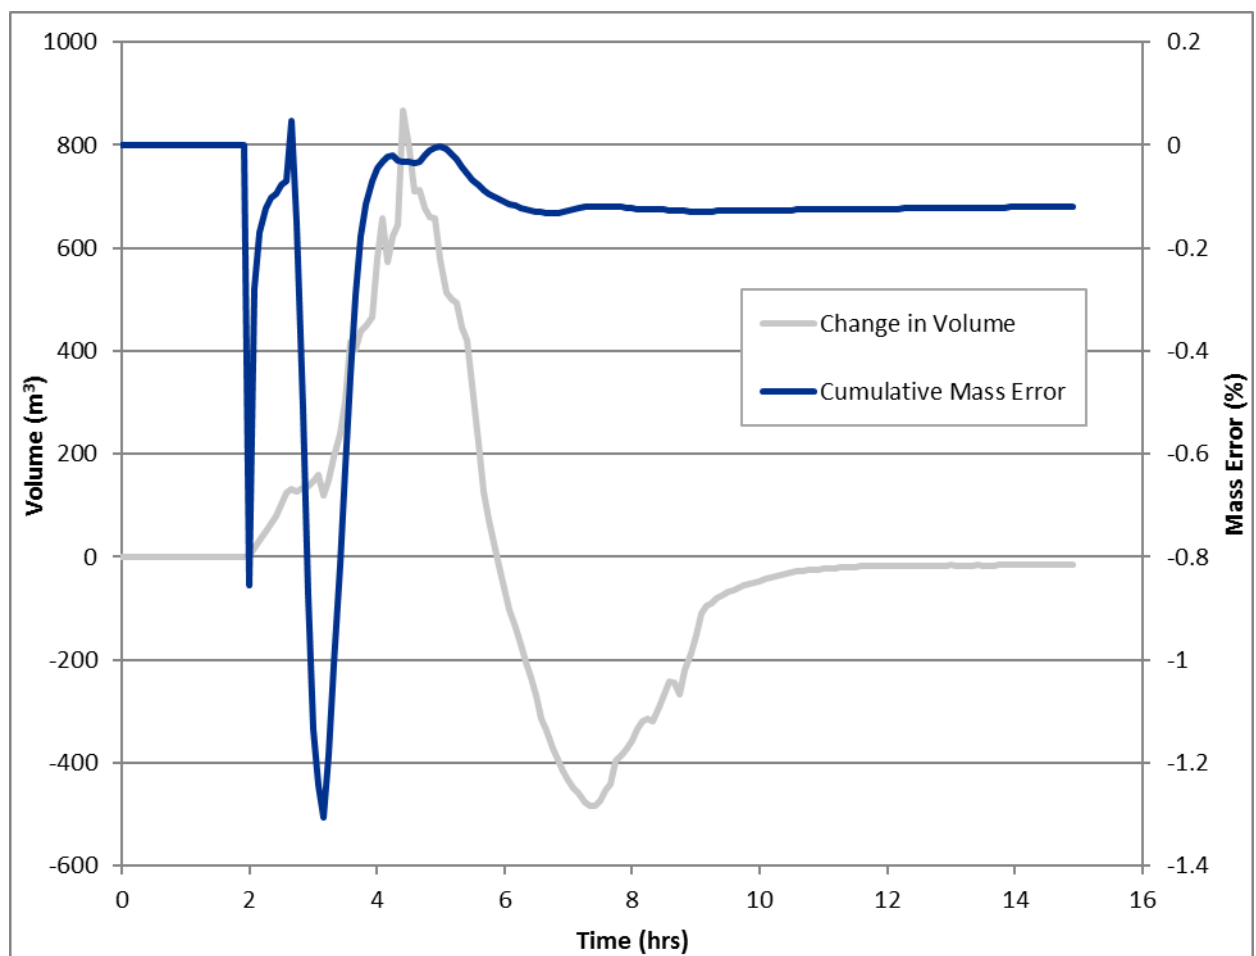
Figure C-12: Mass Balance for the Baseline 1% AEP Simulation

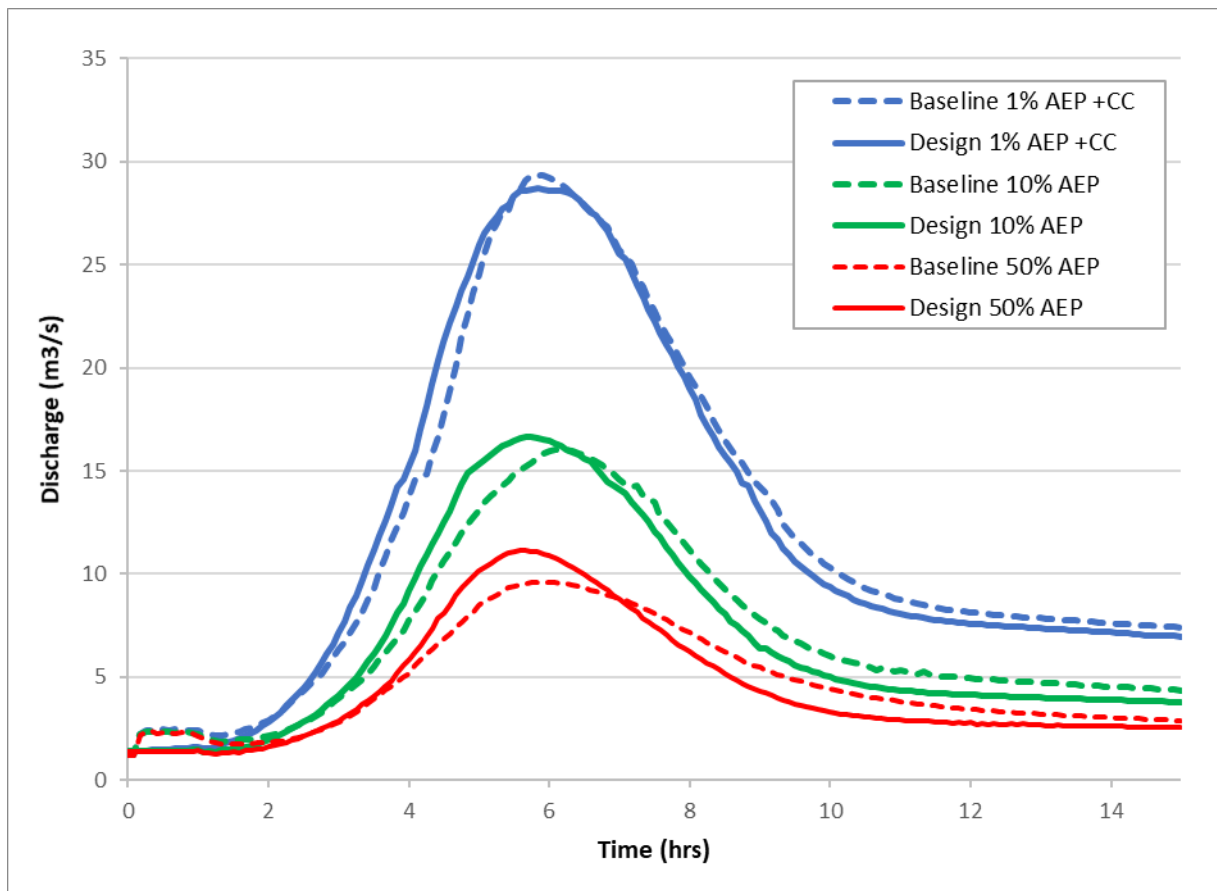
Figure C-25: Final Outline Design In-Channel Flow within the Downstream Reach at the Location of the Flooded Property at Ireby.

Figure C-25 shows the same comparison for the downstream reach at the location of the flooded property at Ireby. Similarly, peak discharge is shown to be decreased in the 1% AEP +CC event following the implementation of the Final Outline Design. For example, in the 1% AEP +CC event, peak discharge at this location reduces from 29.35m³/s in the Baseline to 28.71m³/s in the Design scenario. This decrease in peak discharge was also found in both the 1% and 2% AEP events, whereas peak discharge was found to increase under design scenario in the 10% and 50% AEP events.

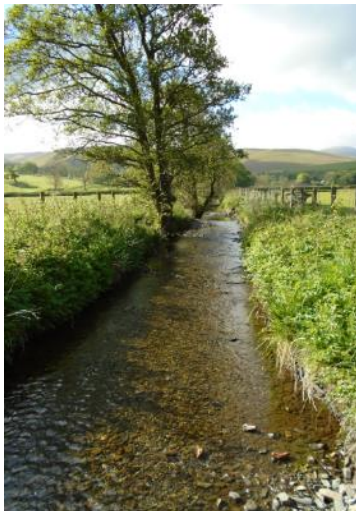
Figure 3.6 : Modified length of the River Ellen (facing upstream)

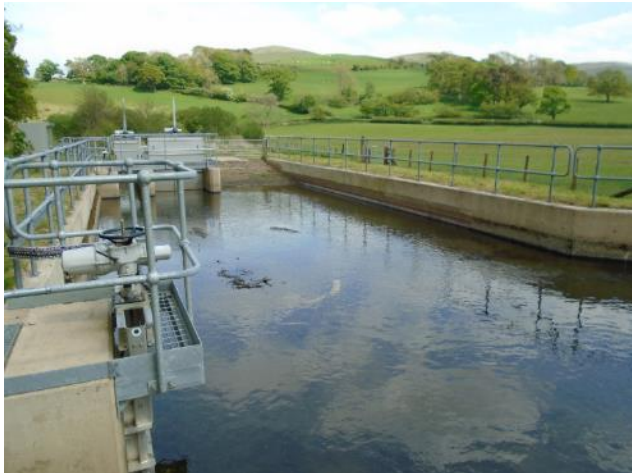
Figure 3.8 : Catchpit on River Ellen (facing downstream)

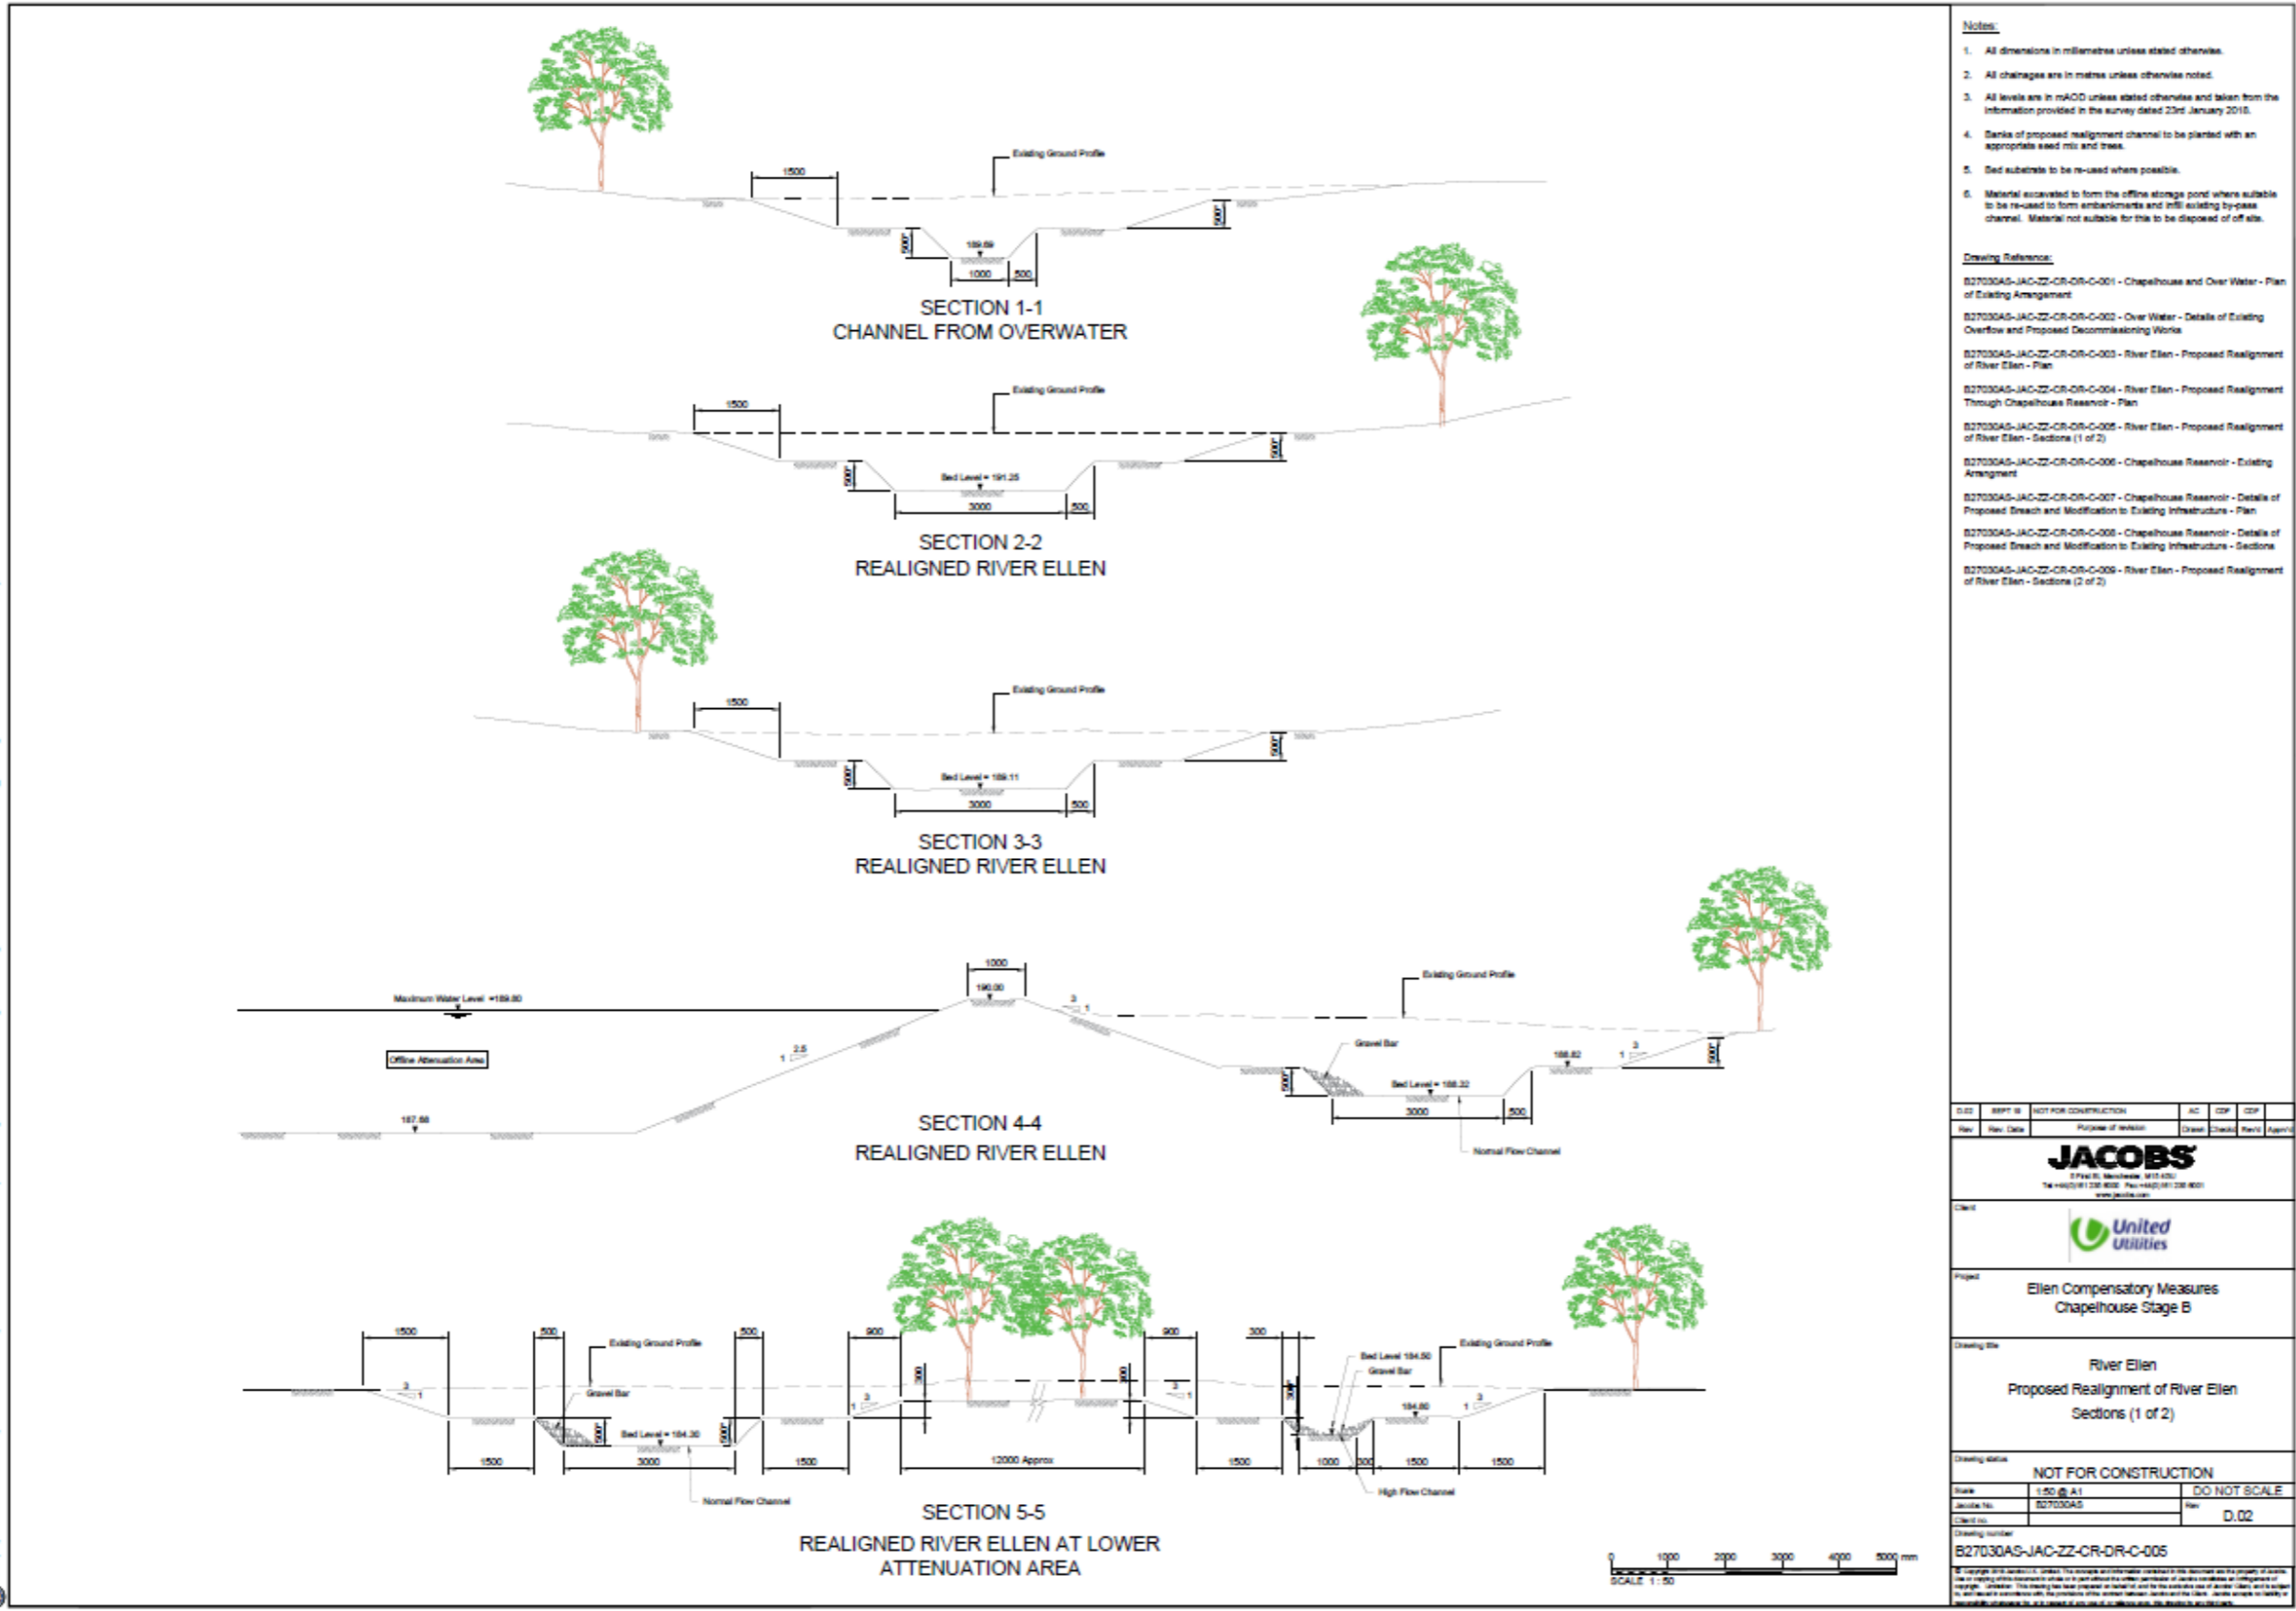
Figure G-5: River Ellen Proposed Realignment Sections (1 of 2) (B27030AP-JAC-ZZ-CR-DR-C-005)
