Barrow Nook

Infiltration Reduction Plan

Last Updated: March 2025

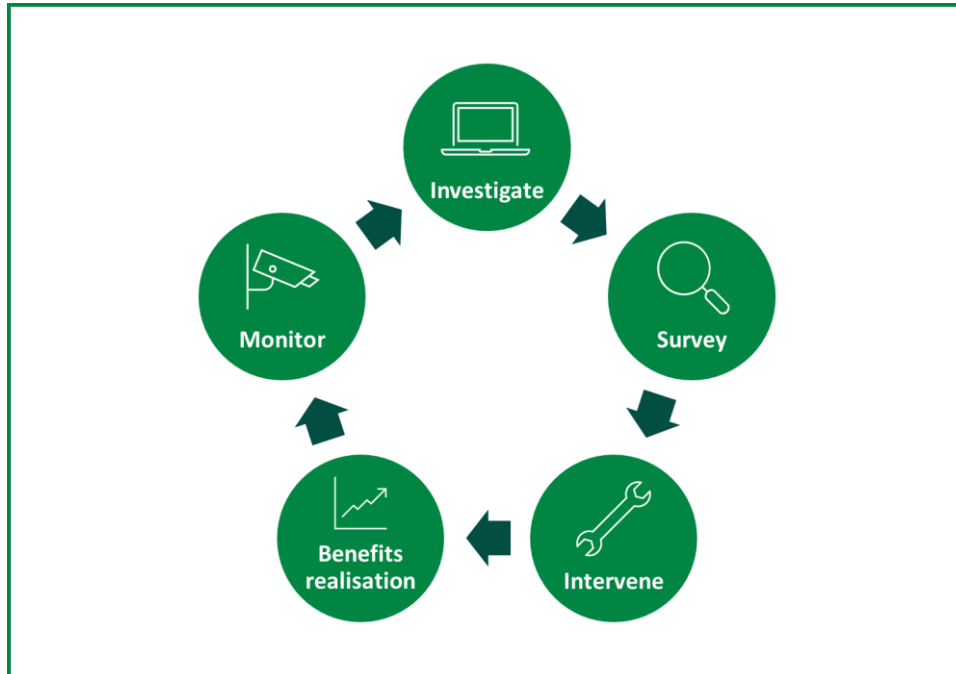
Figure 1: Iterative process to investigate, identify and address groundwater infiltration

Barrow Nook in Lancashire is currently in the intervention stage (see Figure 1) to address infiltration and reduce spills at the Barrow Nook Wastewater Treatment Works Storm Overflow (16930106SO). A desktop assessment concluded that there was the possibility of groundwater infiltration and CCTV surveys of the area confirmed this. Remedial works are expected to be completed in Spring/Summer 2025.

Barrow Nook is currently in the intervention stage of identifying and addressing infiltration (see Figure 1). The site will follow the iterative process displayed in Figure 1 to complete remedial works, monitor the area for their efficacy and identify any more significant areas of infiltration, should they arise.
